**U.S. Environmental Protection Agency
Vasquez Boulevard I/70 Superfund Site
Replacement Certificate**

4723 Vine St.

3557

SITE NAME: VASQUEZ BOULEVARD AND I-70

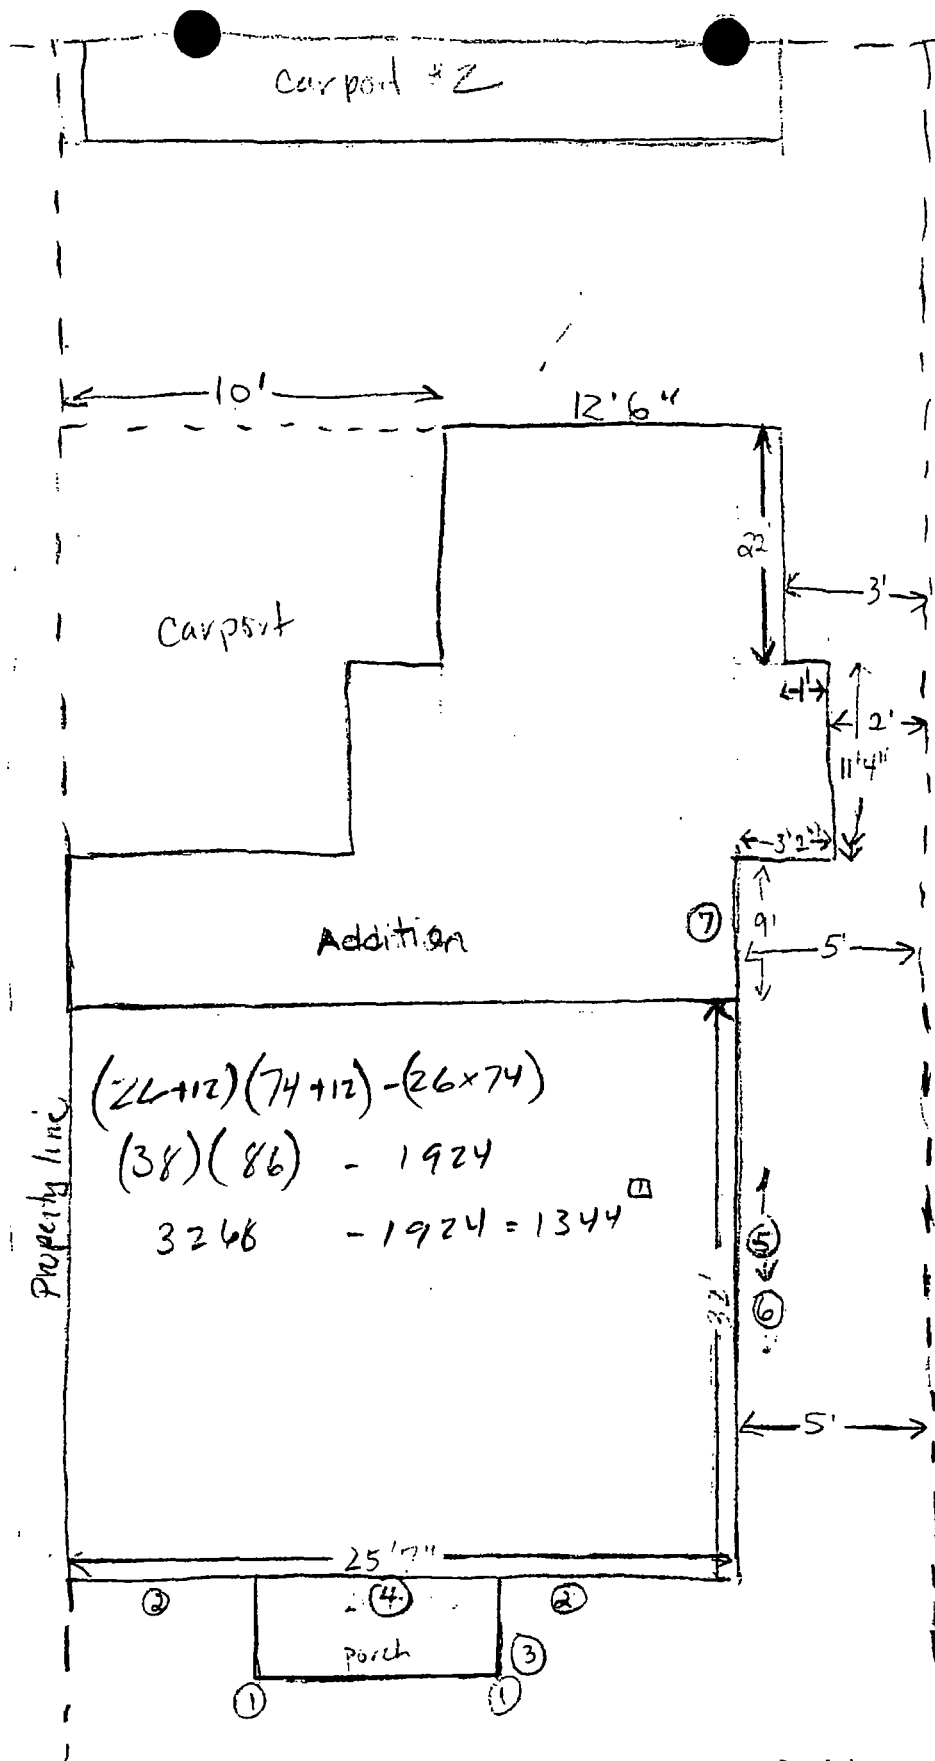
Exterior Walls				Doors/Trim			
Material	deteriorated Area	Peel/Chip	XRF (Lead)	Material	deteriorated Area	Peel/Chip	XRF (Lead)
brick	156.50		11+-3.6				
brick	16.30		2.7+-1.3				
Total	172.80			Total	0.00

Window Trim/Fascia/Soffit/gable end				Patios/Decks/Porches			
Material	deteriorated Area	Peel/Chip	XRF (Lead)	Material	deteriorated Area	Peel/Chip	XRF (Lead)
wood	2.10		27+-9.5				
wood	24.93		11+-3.2	wood	10.75		12+-3.2
Total	27.03			Total	10.75

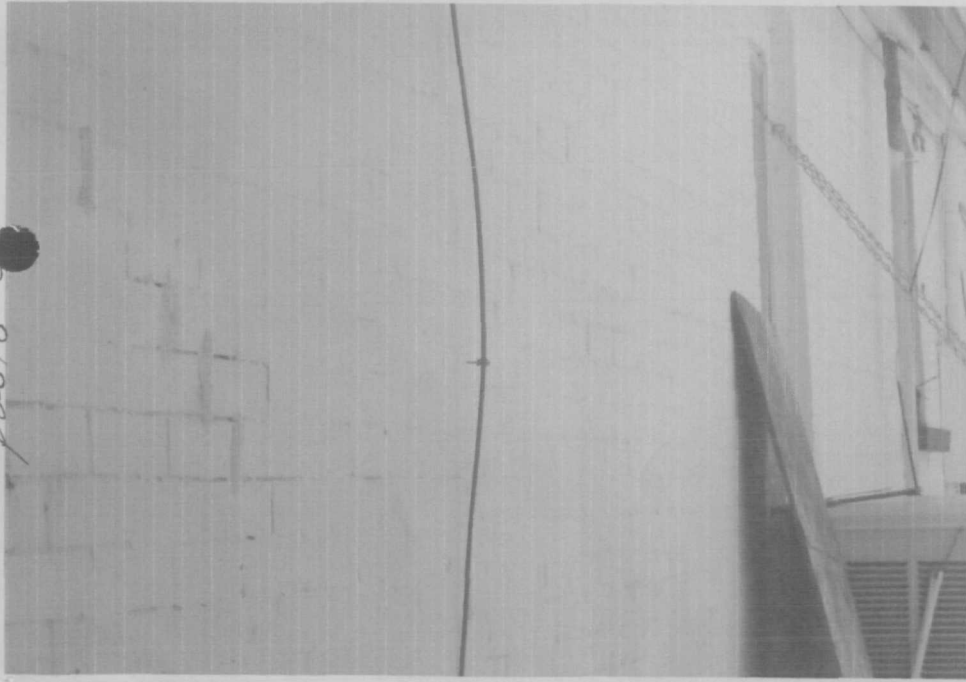
photo 5

Drawing Number	Photo Number	Painted Surface	Material	Color	Total Area of Element (units ft^2)	Percent Deteriorated	Deteriorated Area (units ft^2)	XRF #	XRF Value	pos/neg	
5	5	wall	brick	white	304.00	50%	152.00	49	11+-3.6	pos	
6	6	window frame	wood	white	4.20	50%	2.10	50	27+-9.5	pos	
7	7	foundation below addition	concrete	white	9.00	50%	4.50	53	0.8+-0.2	pos	
		wall (addition)	wood	white			46.00	54	0.04+-0.19	neg	
		corner trim (addition)	wood	white	38.97	100%	38.97	55	0.00+-0.04	neg	
Address: 4723 Vine		Structure:		House							
Date: 8/5/05		Direction:		West							
Investigator: CM/WH											
Time Started: 12:30 pm
